# A summary and analysis of bridge failures

Maynard Horace Tweed  
*Iowa State University*

A Thesis Submitted to the  
Graduate Faculty in Partial Fulfillment of  
The Requirements for the Degree of  
MASTER OF SCIENCE

Major Subject: Structural Engineering

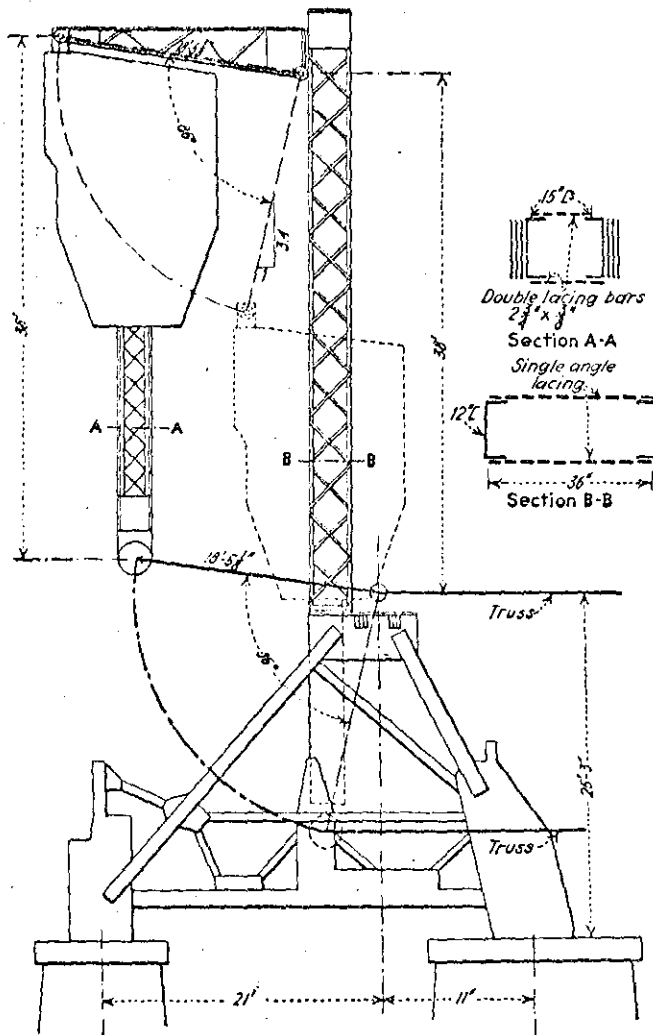
The bridge consisted of a counterweight system as shown in Figure 1. The counterweight consisted of a block of concrete 20'-0" high, 11'-6" wide and 48'-10" long and weighed 750 tons. The vertical distance of the bottom of the counterweight above the roadway varied from 7 to 29 feet. The failure took place when the counterweight was approximately at the half-way point, at which time the span together with the counterweight fell into the river. The failure took place in the north leg of the counterweight tower. There was a complete fracture at the base of the leg. The leg being made up of channels with lacing showed a partly rusted tension break in the rear channel and a bending and tensile break in the other resulting in a forward thrust of the counterweight into

Figure 1. Diagram of counterweight system of Hackensack River Bridge (52)

A board of engineers was appointed to make an investigation into the failure and they made stress measurements on the undamaged west leaf during its operation and found it to be in a state of potential failure. The board reported on observations on the failed structure, observations on the remaining structure, and computed stresses. It was observed that the failure was caused entirely by fracture of the north leg of the east counterweight tower. There were indications of old cracks which had occurred at different times previous to the accident. The metal within the tower, however, appeared to be of good quality.

Observations made on the west structure while being operated at a slow rate showed signs of great stress in the counterweight tower with a result of bowing of the tower lacing. Strain gauges were placed on the channels near the base and a stress of 25,500 psi was observed. A deflection of the top of the tower was found to be over a range of 0.48 feet.

After an investigation by Strauss Engineering Corporation it was concluded that the prime cause of the failure was the abnormally high friction developed at the counterweight trunnion bearing of the north truss which was a result of poor lubrication and poor quality bronze bushings.

The final report of the board of engineers appointed to investigate the cause of the failure indicated that inadequate design was the primary cause of the collapse of the counterweight tower.

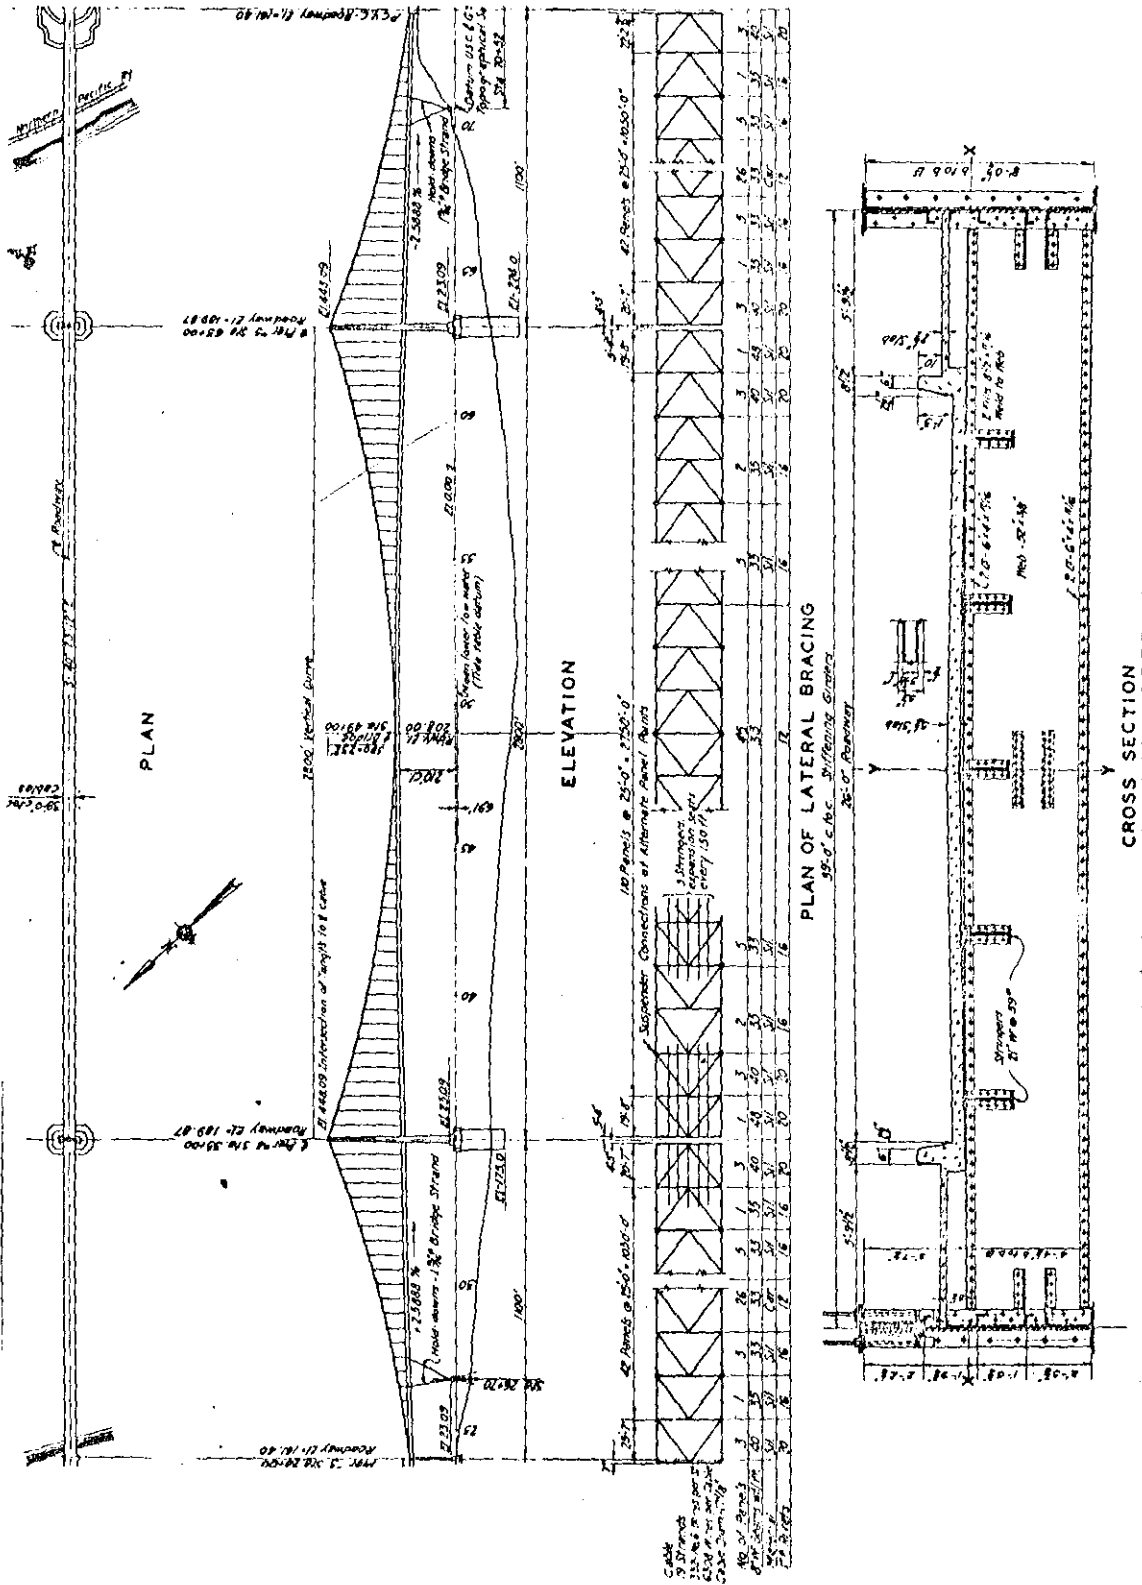
Figure 3. Details of Tacoma Narrows Bridge (56)

November 7, 1940 during a 42 m.p.h. southerly wind blowing at about  $45^{\circ}$  to the roadway. Large vertical oscillations of large amplitudes took place. At first the roadway remained horizontal in the transverse direction but eventually the opposite sides of the roadway began to oscillate out of phase with each other and the main span began to break up and drop into the Sound.

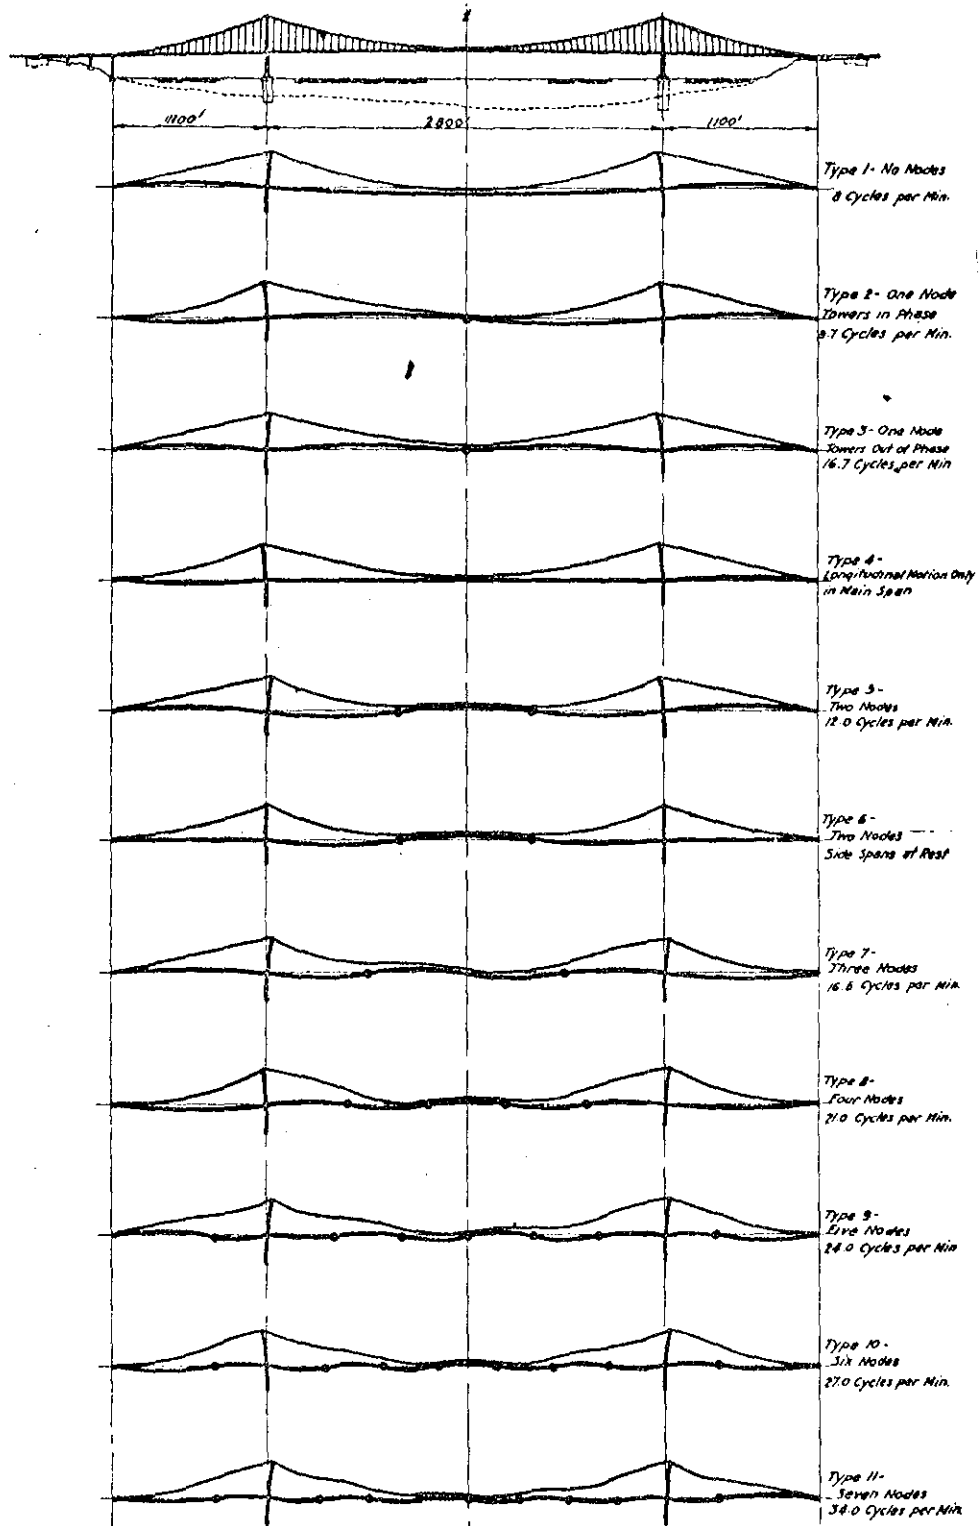
About an hour before collapse the vibration was in two segments with a node at the center of the main span, the two sides of the roadway began to vibrate out of phase with each other resulting in one side

Figure 4. Modes of oscillations of Tacoma Narrows Bridge (56)

going up while the other side was going down. Many photographs have shown this particular action. The deck would tilt to about  $30^{\circ}$  with the horizontal and the amplitudes increased to about 14 feet. The difference in elevation of the two sides of the roadway would be about 28 ft. at maximum amplitude.

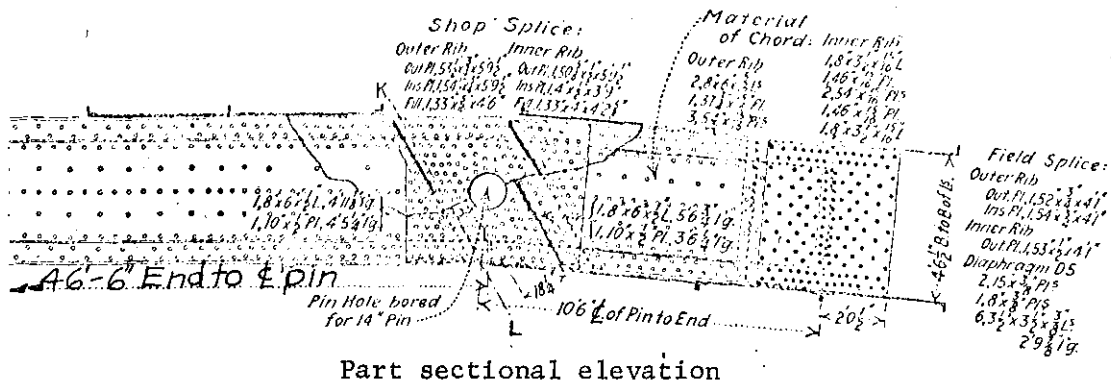
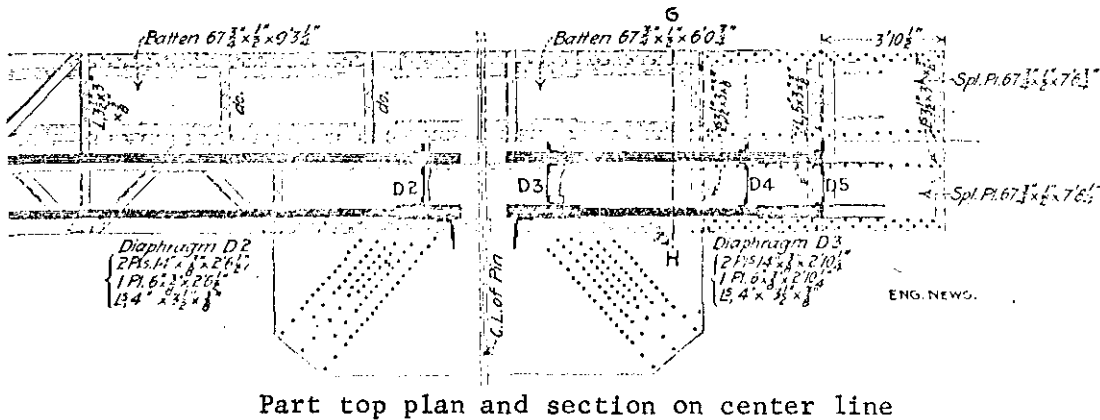
The deflection of the member was discovered about three days prior to the collapse. A careful watch was made of it for the next two days and no more deflection was noticed but the latticing began to show signs of severe stress. A telegram was sent by the inspector in charge of erection, Mr. McClure, to Mr. Cooper. Mr. Cooper immediately wired the

Figure 7. Member A9L of First Quebec Bridge (57)

The compression member A9L was constructed of four massive plate webs each made up of four rolled plates, stitch-riveted together to form

one built up plate nearly 4 in. thick. These four webs were bound together by latticing so as to act as one member. The outside dimensions of the member were 5'-7 1/2" x 4'-6 5/8". The member was reported to have had a kink in one of the inner webs before it left the fabricating shop. The member was also involved in a railway accident during shipment to the site. It was reported that the member had been repaired with excellent workmanship. It is very improbable that the workers would have placed the member in its position in the bridge had it not been straight. The length of the member was 57 ft. and if the deflection of 2 in. existed before erection it would have been noticed and rejected. The resident engineer said the deflection had always been in the member and the deflection was not caused by overstress. This was not the feeling of the other responsible men on the job. Every member was inspected by several people and it is not probable that it would go unnoticed in such an important and massive structure.

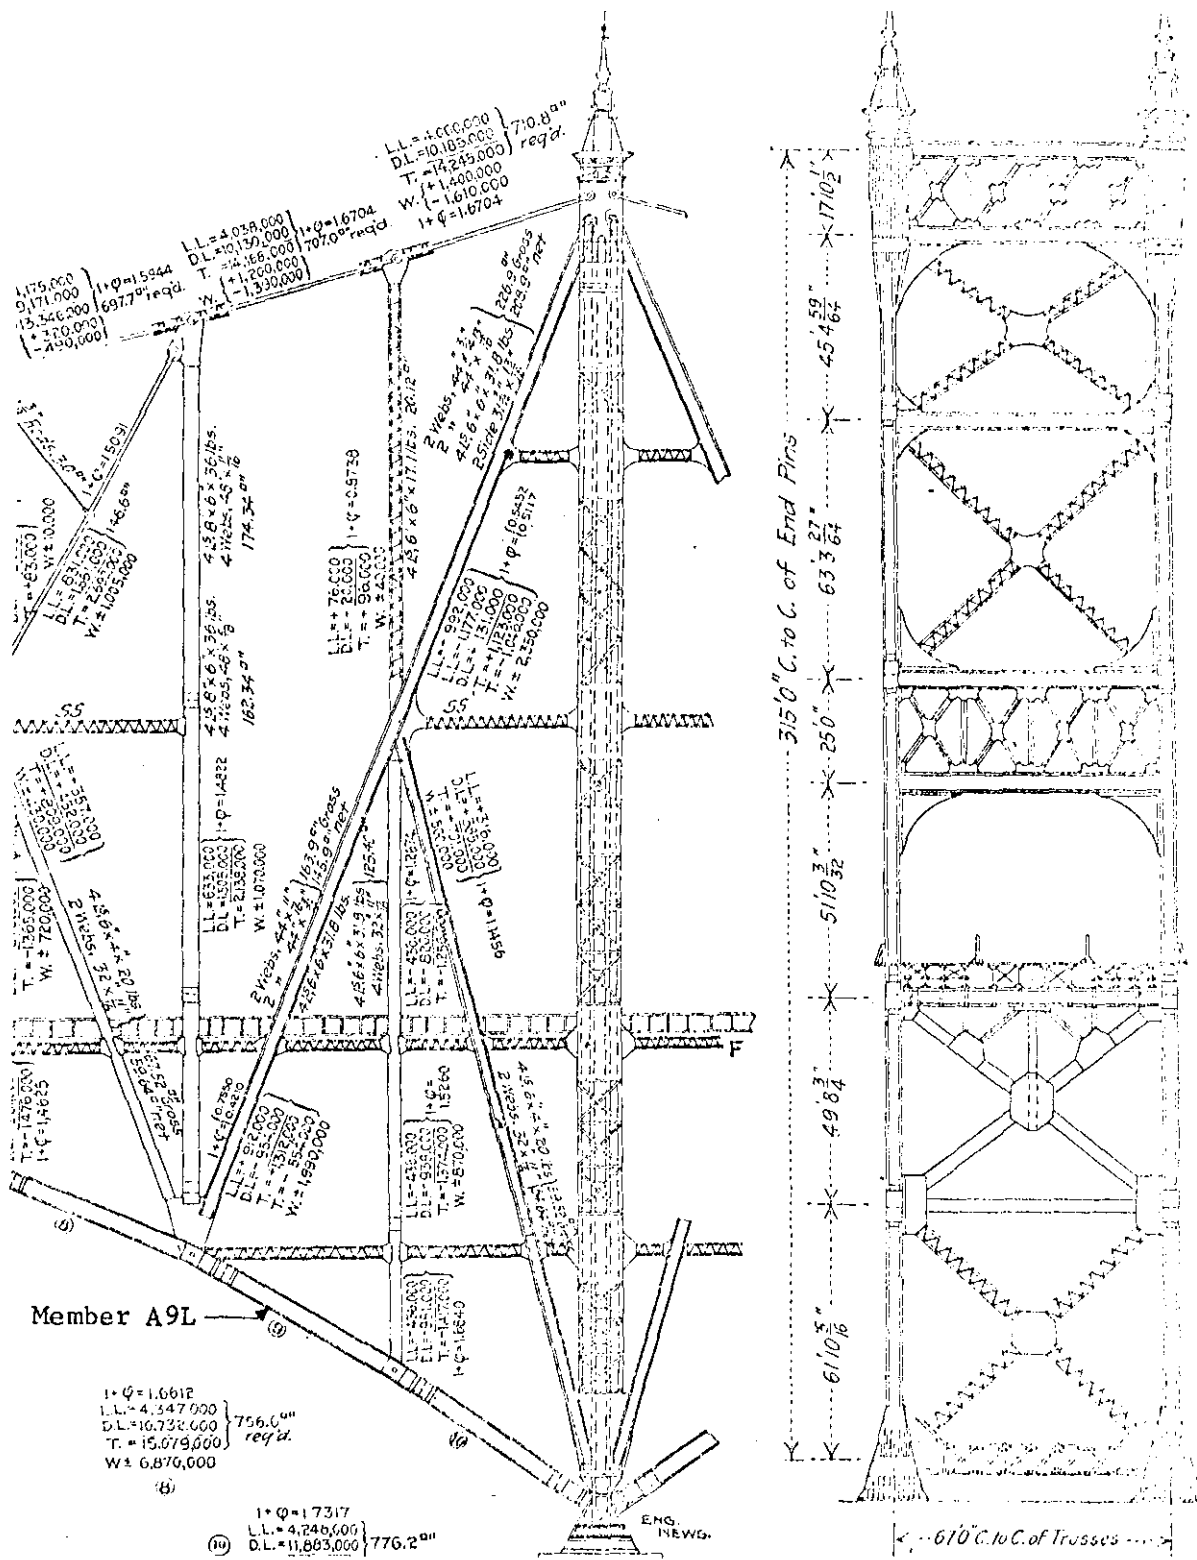
Figure 8. Part stress diagram of First Quebec Bridge (57)

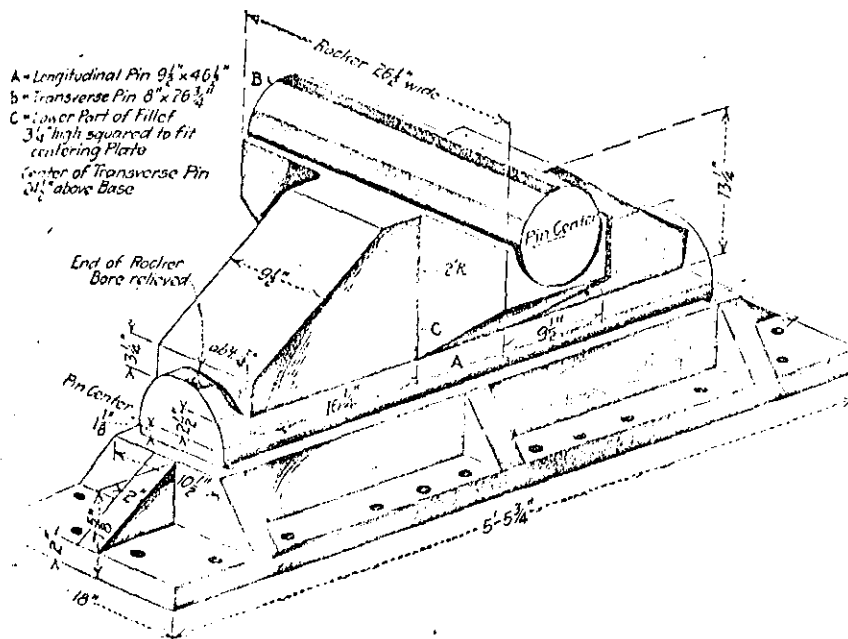
girder (see Figure 10). The lifting girder was then connected to the lifting hangars as shown in Figure 11. There seemed to be a possible unstable condition here because the point at the connection to the hangar chains was at about the same elevation as the universal joint. With the truss supported about 4 ft. above this point a small amount of eccentricity would tend to tip the girder. It was first thought that fracture of the rocker casting was the cause. However the dropping of the corner of the truss could have caused a sudden thrust and a possible rotation of the girder, allowing the one corner of the span to slip off and into the river. Every precaution had been taken to keep the span level during the jacking. The lifting chains and girders were all in good condition

Figure 10. Diagram of rocker used for hoisting suspended span of the Second Quebec Bridge (12)

following the accident. The load on each of the rockers was 1,300 tons and this great load could account for the loud report preceding the collapse.

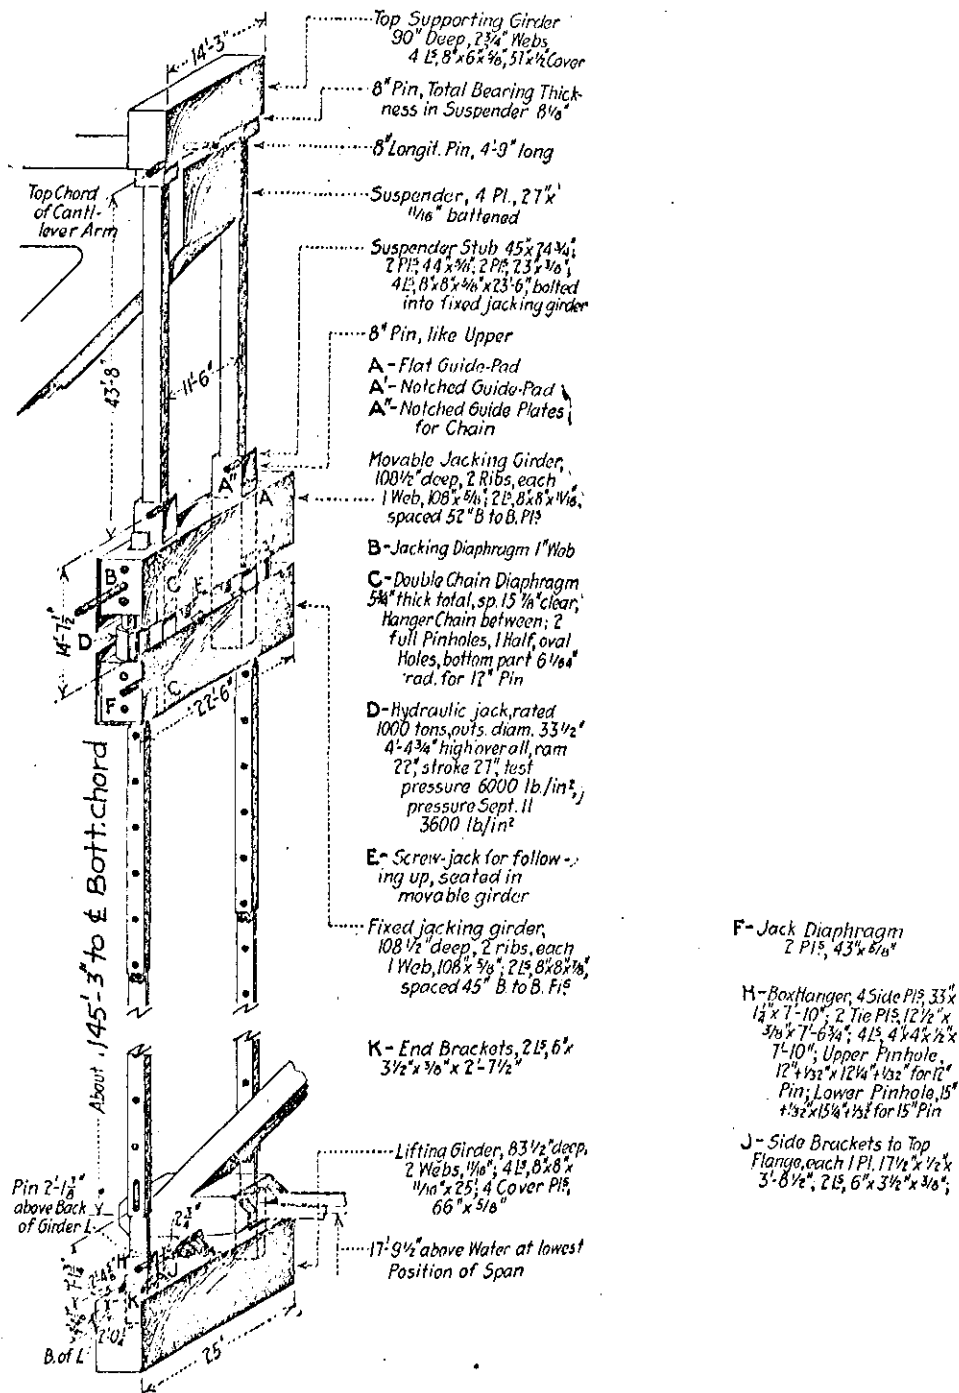
Figure 11. Diagram of hanger used for hoisting suspended span of the Second Quebec Bridge (12)

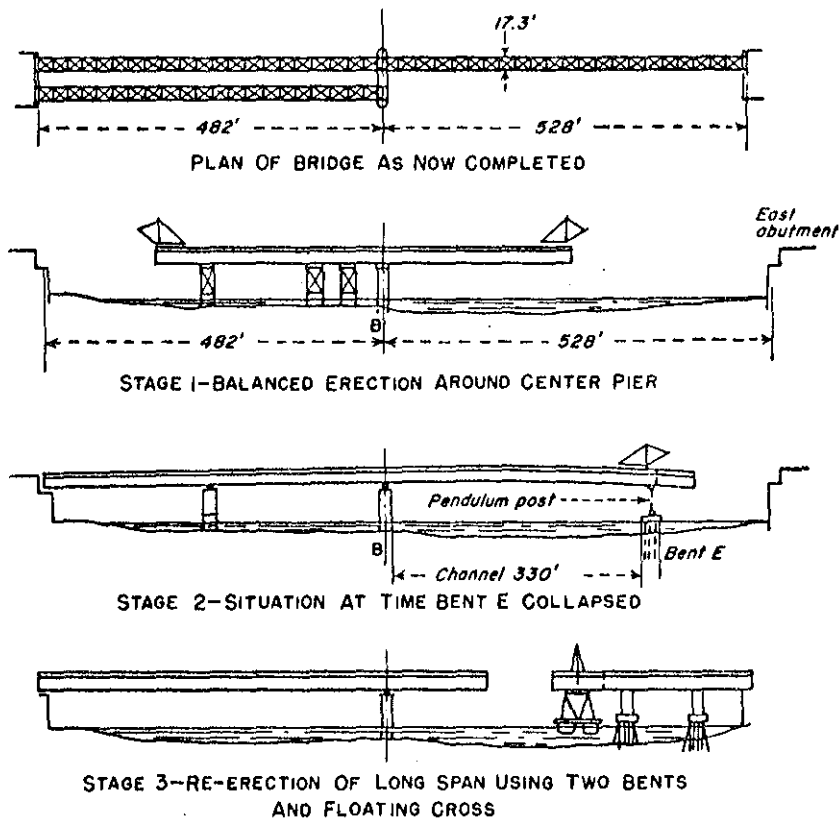
In August of 1950 the construction was completed on the largest welded plate girder bridge in the world at that time (64). The bridge site was at Manneheim, Germany across the Rhine River. The construction was started in 1939 and the uncompleted bridge failed in December of 1940 when erection of the main girders was nearly complete. For erection sequence see Figure 12. Thirty-six construction workers lost their lives in the collapse which was initiated by the carelessness of the erection superintendent.

Figure 12. Erection sequence of Frankenthal Bridge (64)

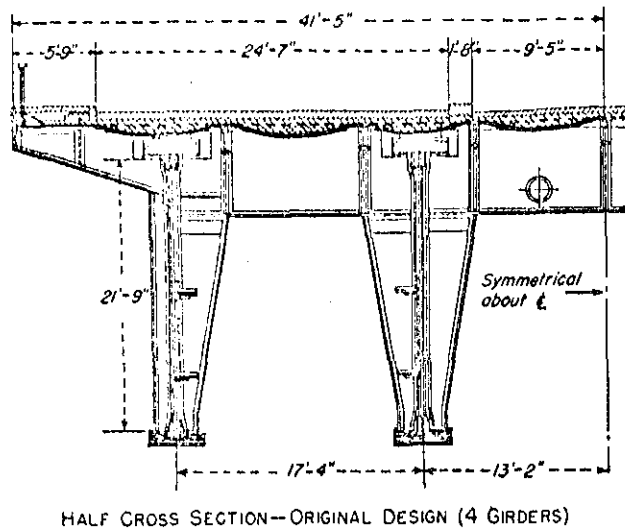
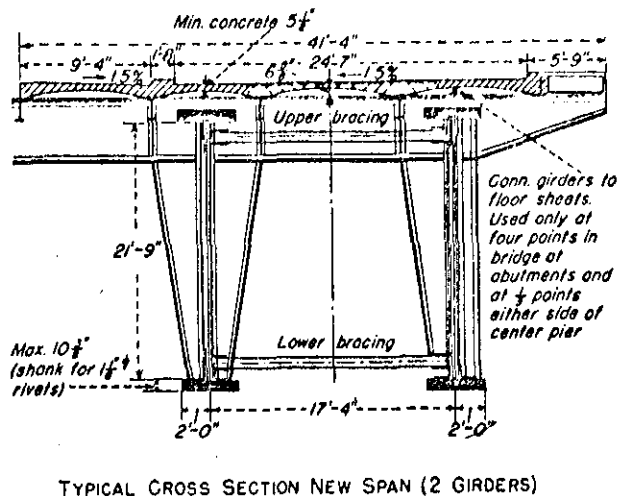
Figure 13. Diagrams of the original cross-section and the revised cross-section of the Frankenthal Bridge (64)

Reconstruction of the east span began in 1950 and it was decided to use only two girders instead of the four girders in the original design (see Figure 13). This resulted in a very complicated and costly transition and it was decided to cut the floor beams of the western span at the centerline. This alteration resulted in a more slender span and thereby required lateral bracing between the two girders.

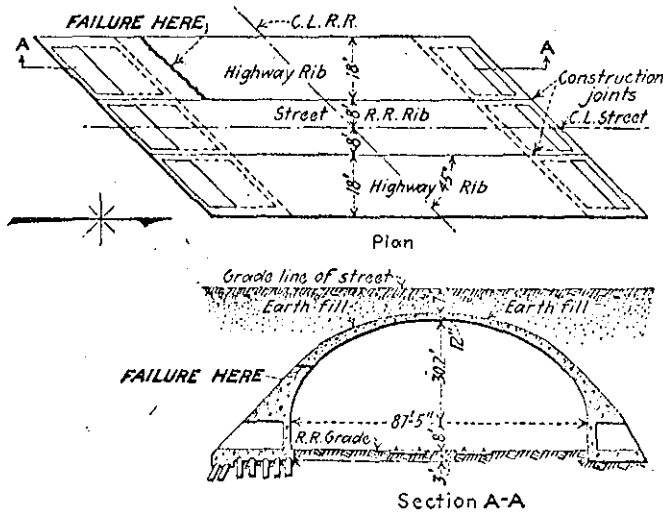
The bridge was an unusual type as shown in Figure 15. The shape of the arch was elliptical and carried a considerable amount of earth load as well as a railroad and two highway lanes. The width of the arch was 52 ft. which was made up of three separate arches of 18 ft., 16 ft., and 18 feet. These arches acted completely independent of each other.

Figure 15. Sketch showing crack in Tacoma, Washington Bridge (39)

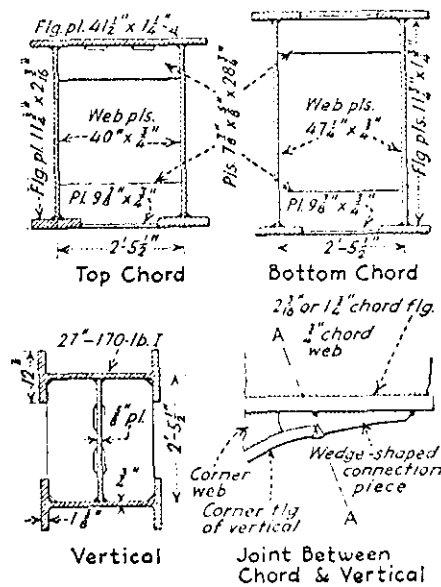
Figure 16. Structural details of Hasselt Bridge members; numerous fractures occurred along line AA (25)

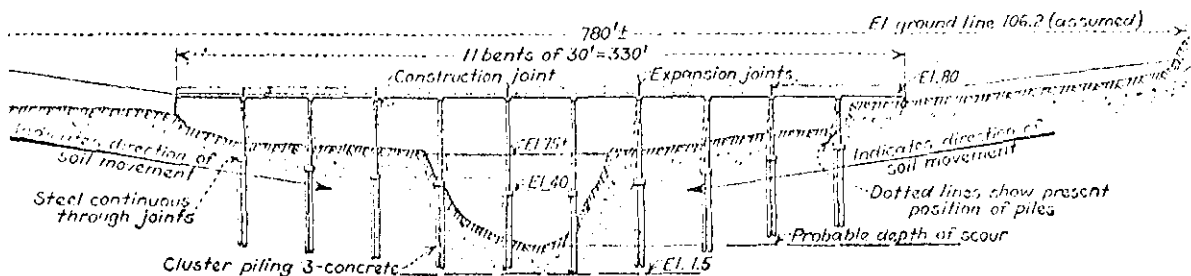
In early 1920 there appeared to be a lateral movement of the center of the bridge indicated by cracks forming with apparent tilting of the

Figure 18. Reinforced concrete trestle over New River in Imperial Valley, showing movement of bents (40)

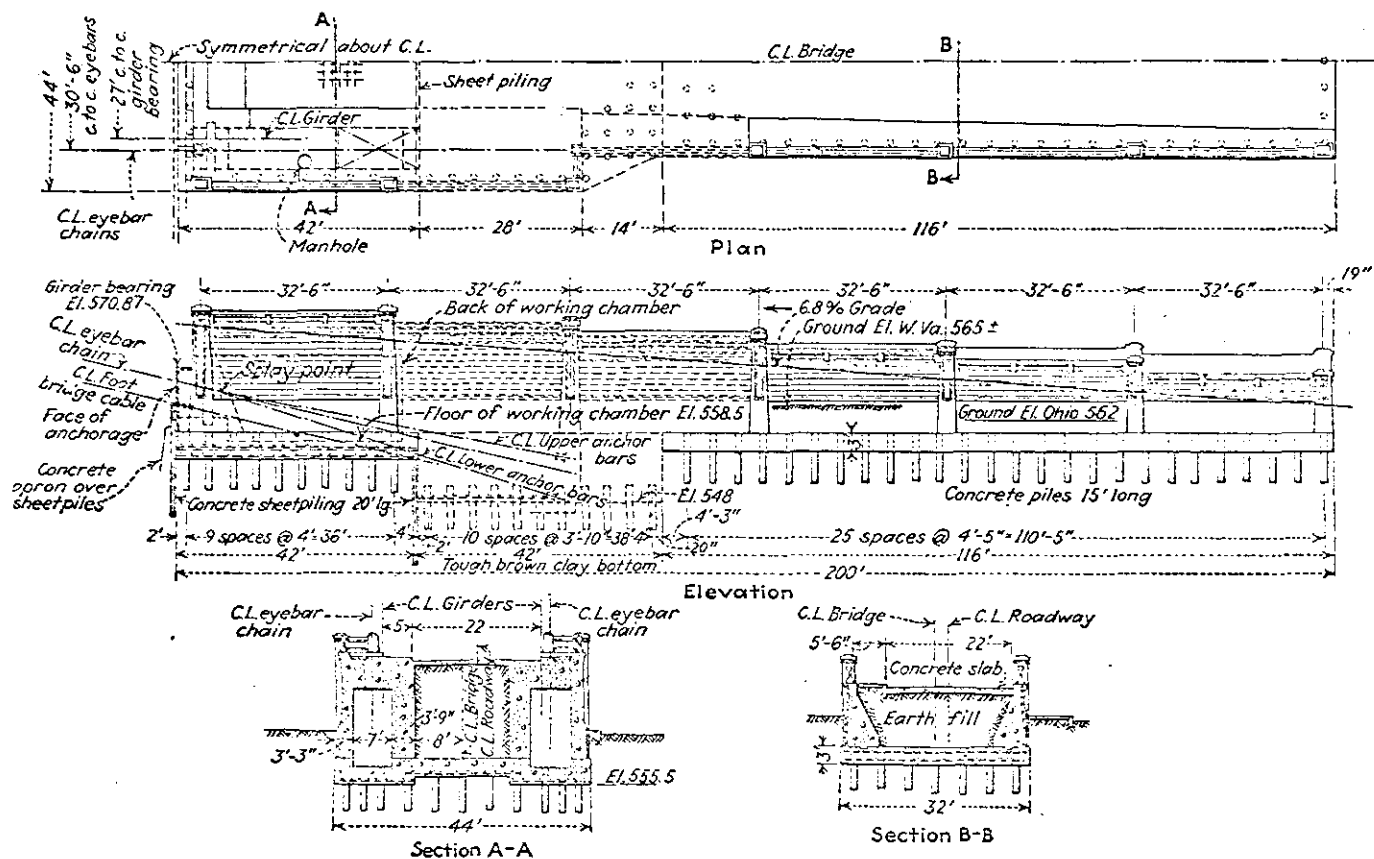
Figure 19. Details of anchorage of Point Pleasant Bridge (49)

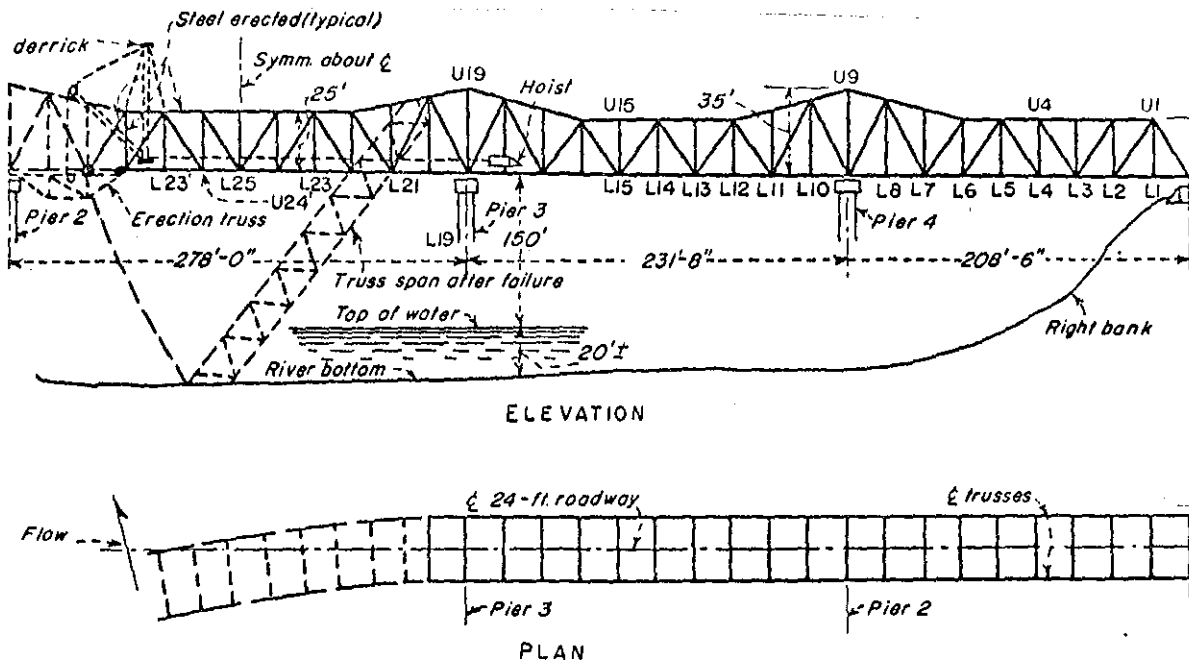
At the time of the collapse there were attempts being made to beef up some of the main truss members to resist some of the erection stresses. The top chord which broke had been increased from a design section of two 13 in. channels of 31.8 lbs. per ft., and one 22 in. by 1/2 in. cover plate to two 13 in. ship channels at 50 lbs. per ft. and one 22 in. by 1/2 in. cover plate. The erection truss which was being placed in position at the time of the accident was to be under the downstream truss. The other erection truss was not in position at the time. The weight of the erection truss was about 5 tons and was being boomed out by the derrick to be suspended beneath the main truss. It

Figure 21. Details of Bluestone River Bridge showing collapsed center span (84)
